# Manhole Inspection Summary

Manhole # S37A\_\_014MH

**Inspection** ☐ Is Incomplete Rating: **5) Immediate Attention Required**

Insp Date: **9/18/08 12:13 PM**

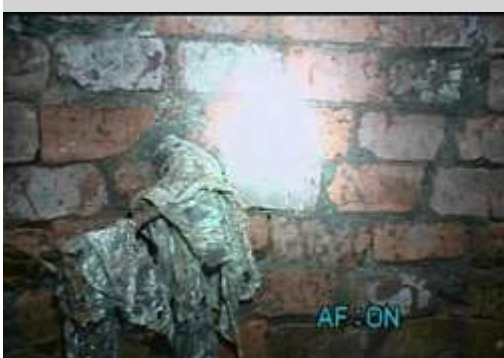
Defect 3

☒ **Evidence Of Surcharge** Depth: **2.4** (ft.) ☐ Active Surcharge Present

evidence of surcharge

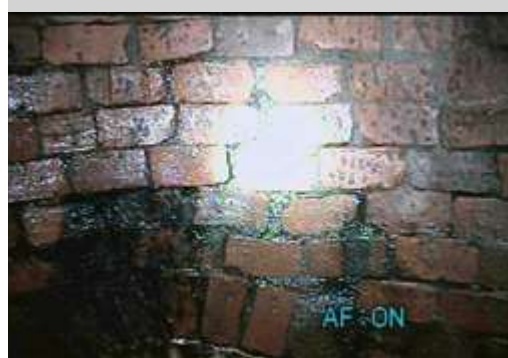
Defect 2

Infiltration: ☐ None ☐ Joint ☐ Cracks ☐ Mortar ☐ Roots ☒ **Wall**

infiltration in barrel wall

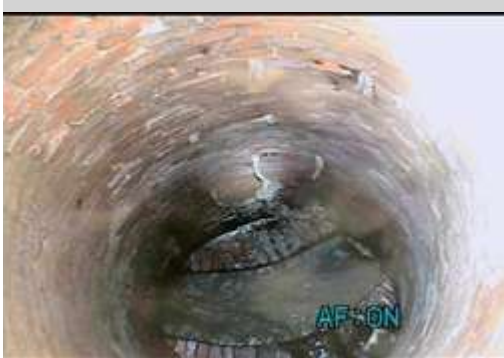
Defect 1

Count: **6** Missing: **4** ☒ **Corroded**

cor. steps

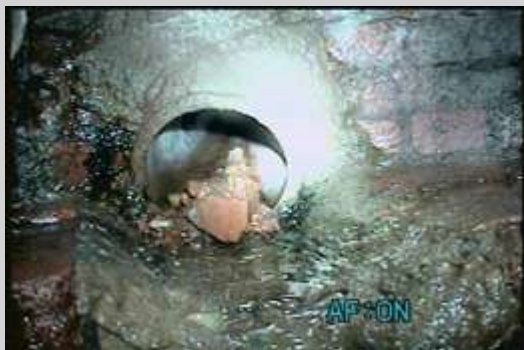
8 O'Clock Inflow

Deposits: ☐ None ☐ Mud ☐ Sludge ☒ **Debris** ☐ Grease

Silt Depth: 3 (in.) Deposits Extent: **Light**
